SEPTIMIUS MARA (*) & SERBAN NICOLAE VLAD (**)

POSITIVE EFFECTS OF NATURAL HAZARDS ON CULTURAL HERITAGE IN ROMANIA

ABSTRACT: MARA S. & VLAD S.N., *Positive effects of natural hazards on cultural heritage in Romania*. (IT ISSN 0391-9838, 2008).

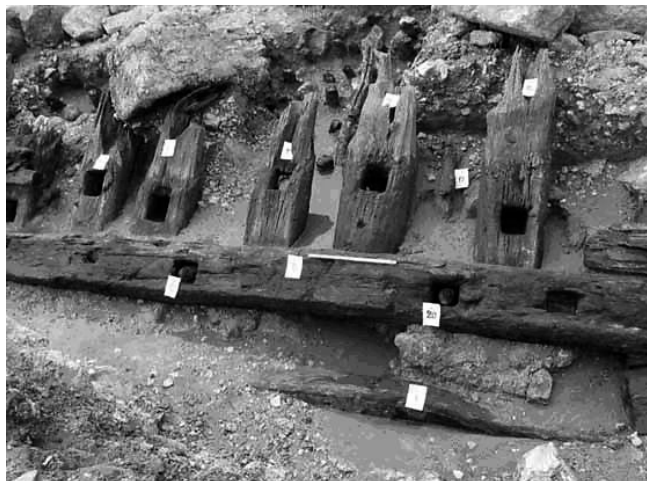
FIG. 5 - A unique well preserved structure of the fortress basement made by intricate oak trunks grid on the Danube muddy riverbed.

Studies in the area have been conducted since 1973 at a probable docking zone for ship repairing, because of the presence of some wooden remains (fig. 5). During 2003 important vestiges were revealed in the Danube river bed. A real surprise was the discovery in situ of a wooden basement structure of the fortress walls (fig. 5), exhibiting a unique building technique for unstable and flooded terrain, so far unknown throughout any other Byzantine vestige.

The building technique of the Byzantines consisted of a network of oak trunks, disposed on a grid with intervals of 0.4 m from each other.

The whole wooden structure, placed directly on the muddy soil, was first covered by a unitary masonry plaque,

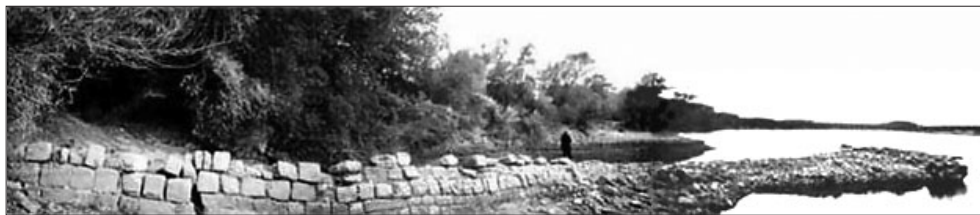
FIG. 3 - Part of the defense wall of the Byzantine Fortress - Ostrov, on the «Păcuiul lui Soare» island, known as Vicina, was initially a military naval base and inhabited until mid-15th century.

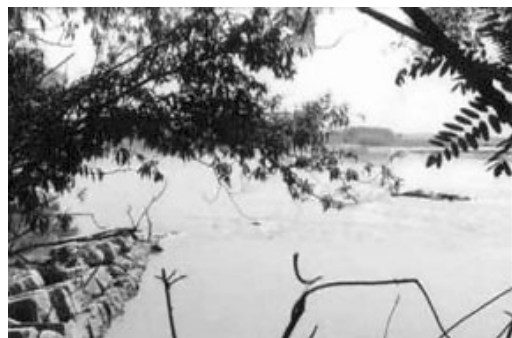
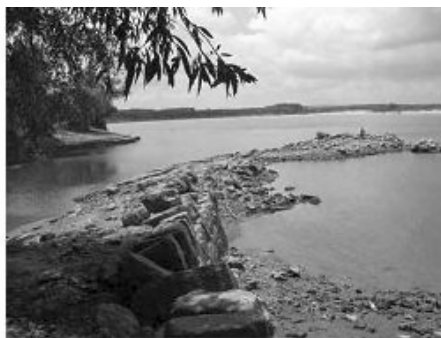
FIG. 4 - The southern part of the Byzantine fortress is normally covered by the Danube water (left), and the same wall revealed by the 2003 severe drought (right).

The extreme low levels of the Danube waters during summertime of 2003, allowed archaeologists to conduct investigations in the southern extremity of the Byzantine fortress, which is normally submerged by water (figs. 4).

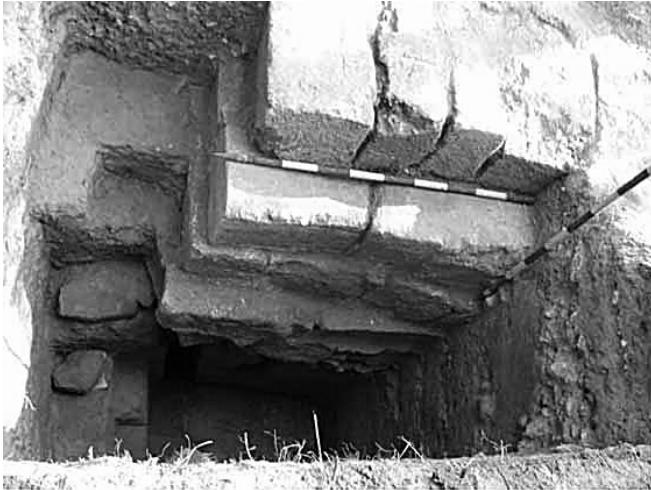
FIG. 6 - Detail of the massive masonry walls, with large hand carved limestone bricks.

The foundation terrain of the island was a real challenge for the ancient builders, because the basement of the fortress consists of unconsolidated clay and sand and the river level and groundwater table show large variations. Until the recent discoveries of 2003, nobody could understand how the muddy soil of the island supported over the centuries the heavy weight of massive masonry of the defence walls of the Byzantine fortress (fig. 6).

which became the base for the rest of the massive walls of the fortress, made mainly by carved and hand fashioned limestone blocks, originated from a nearby quarry, on the left bank of the Danube.
